## Vancouver Aquatic Centre Rehabilitation – Memorandum

**Attention:** Emma Artis, City of Vancouver  
**CC:** Tina Mathur, City of Vancouver  
**From:** John Sherstobitoff, Ausenco  
Reza Mortazavi, Ausenco  
Oon-Soo Ooi, Ausenco  
**Subject:** Options for Rehabilitation and Retrofit  
**Date:** February 17, 2023  
**Document Ref:** 107293-01-MEM-001, Rev.0

**Re: Vancouver Aquatic Centre Structural Steel Corrosion Assessment**

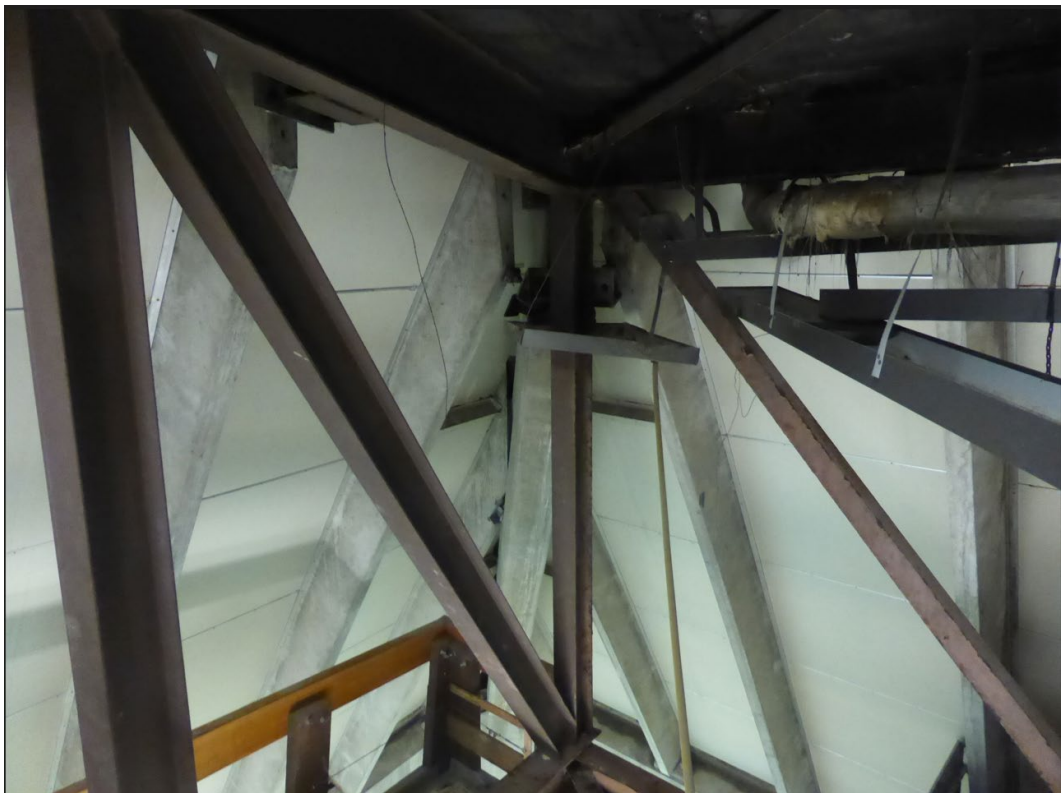
- John Sherstobitoff attended a site visit on September 28, 2022.
- Ausenco reviewed information provided by the City (see Section 1 above).
- Regarding two precast panel bolt/pad connections in attic space; SW and SE corners (as observed during site visit September 28). The bolt/pad appeared to be very near the edge of the support, rather than centred on the support.
  - The noted condition will be assessed by Glotman Simpson and reported on in their Q1 2023 report.

**Figure 1: South West Corner Precast Panel Bolt/Pad Connection**

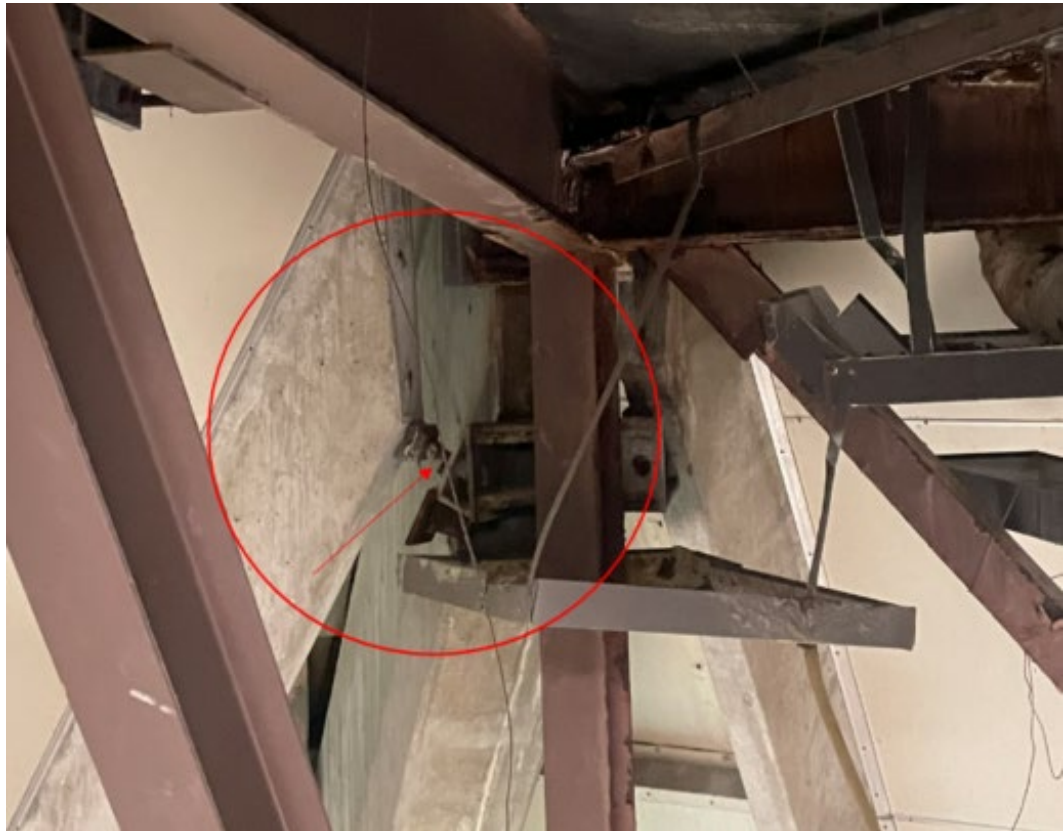
**Figure 2: South West Corner Precast Panel Bolt/Pad Connection-Close-up**

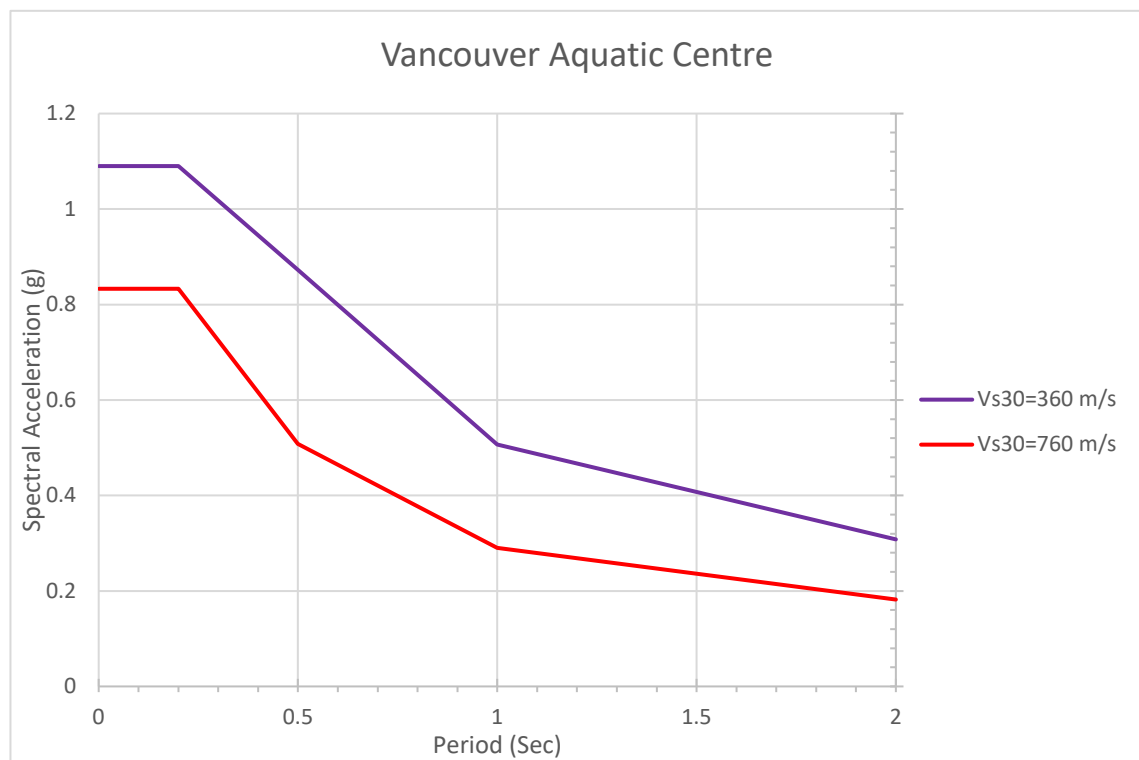
**Figure 3: NBC 2020 Response Spectrum for Aquatic Centre Location, Upper and Lower Bound for Site Class C Soil**

- Obtaining Vs30 may result in 24% to 43% reduction in seismic demand, compared to using a default Site Class C value (upper bound curve per NBC 2020 if Vs30 is not obtained), for structure with fundamental period less than 1 second.
- Based on NBC 2020 and assuming 1.3 for Importance Factor (Community Centre), fundamental period of structure less than 0.2 seconds, and  $R_d = 1.5$ ,  $R_o = 1.3$ .
  - Lower Bound (Red Curve) Lateral EQ Force = 0.37 W
  - Upper Bound (Purple Curve) Lateral EQ Force = 0.58 W

Therefore, obtaining Vs30 could result in up to 36% reduction in lateral earthquake design forces for a structure with a period of less than 0.2 seconds. It is recommended to obtain Vs30 for the site.

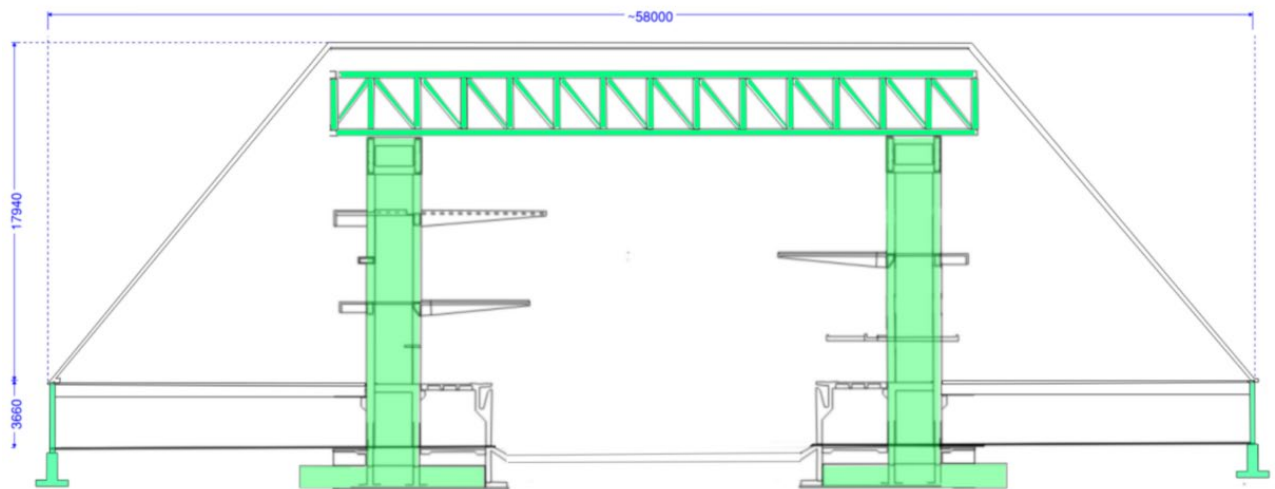
- It is proposed that the following structural components be retained or removed as part of a rehabilitation and seismic retrofit of the facility at the existing location. Figure 4 highlights in green, those components proposed to be retained.
  - o Retain the steel truss superstructure.
  - o Retain 4-40" square columns and east and west diving towers.
  - o Retain the seven main precast concrete roof girders.
  - o Retain bleachers and washroom structures.
  - o Retain (and reinforce if necessary) the exterior concrete walls.
  - o Remove the pool walls and deck, replace entirely.
  - o Remove and replace the roof deck with a lighter and lower maintenance deck.
  - o Remove and replace the exterior siding with a lighter weight envelope; it is understood that more glazing is desirable.

**Figure 4: Sectional View of the Building – Looking South**

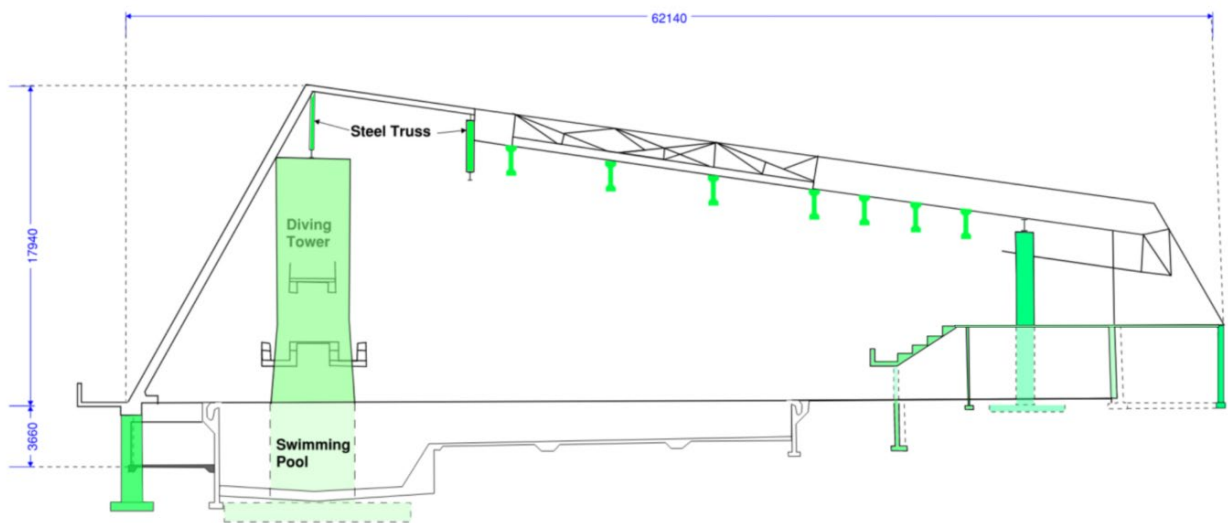
**Figure 5: Sectional View of the Building – Looking West**

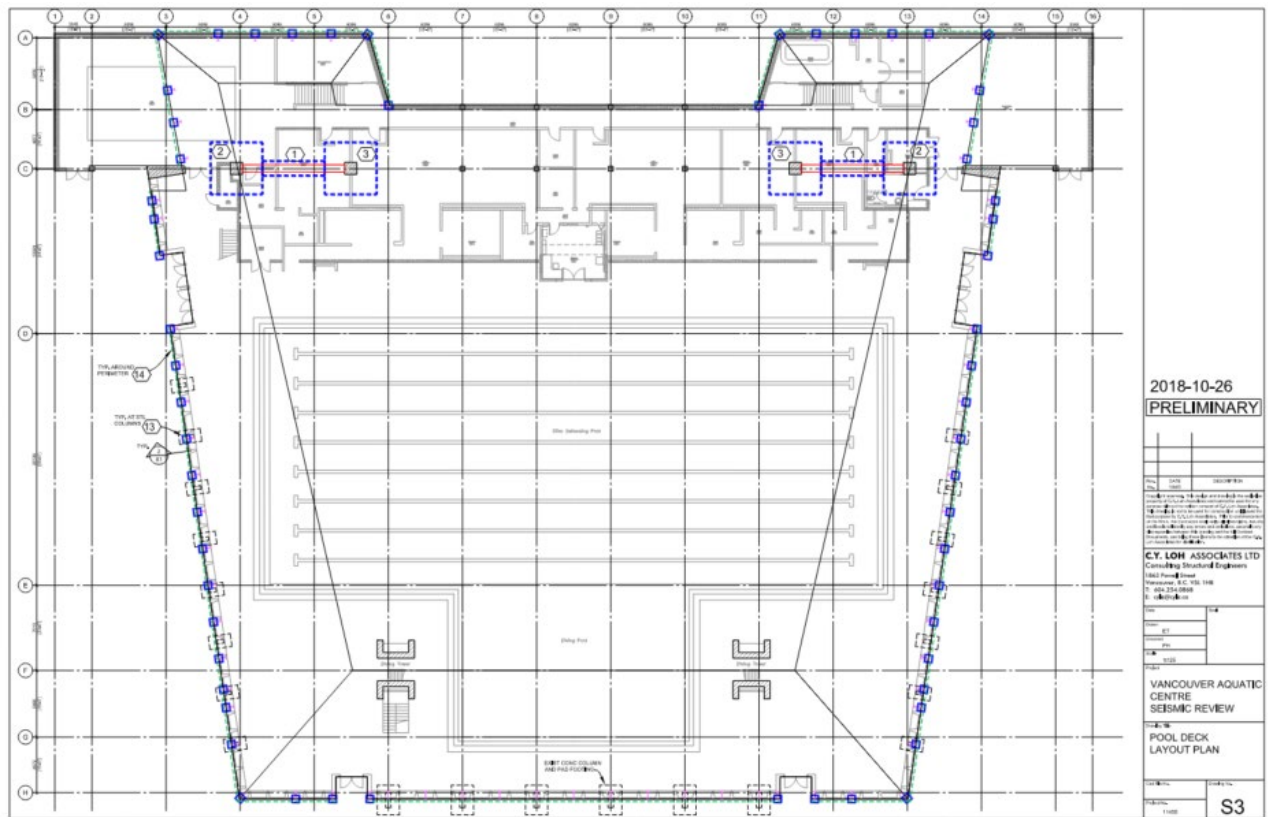
The C.Y. Loh Associates Ltd. report dated October 26, 2018 suggested the following concept:

Figure 7: Option 1 – Suggested Shear Wall and Perimeter Upgrades

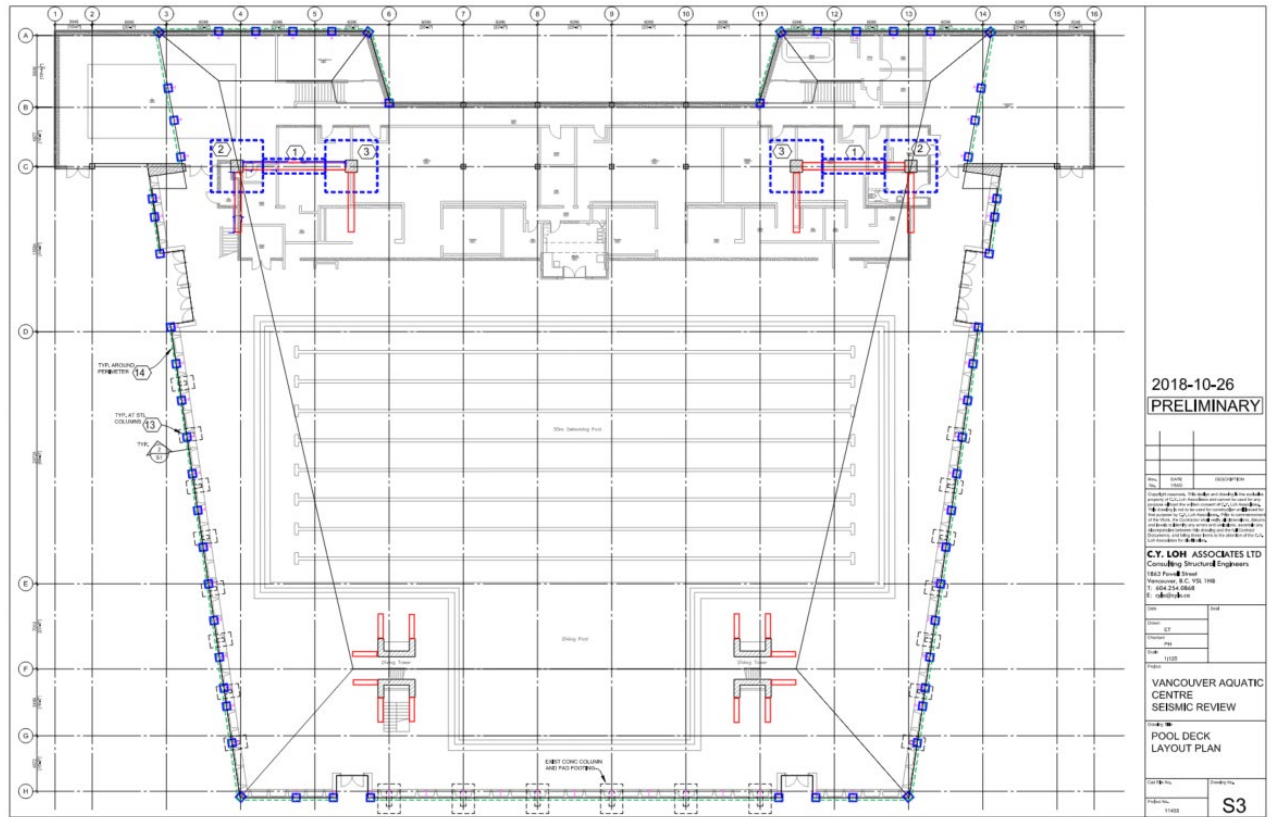
- Add shear walls in between and perpendicular to the 40" columns, for both NS and EW loading.
- Add concrete shear walls (fins) in two directions at the diving towers, away from diving pool, to augment both NS and EW lateral load capacity.
- Lateral bracing of roof truss to connect to above SFRS items.
- As per Option 1, removal of the heavy precast cladding and roof elements and replacement with a new structure that retains the form of the existing building; however, the new envelope could be non-SFRS to resist only wind pressure and snow loading.

Figure 8: Option 2 – Interior SFRS System, Shear Walls

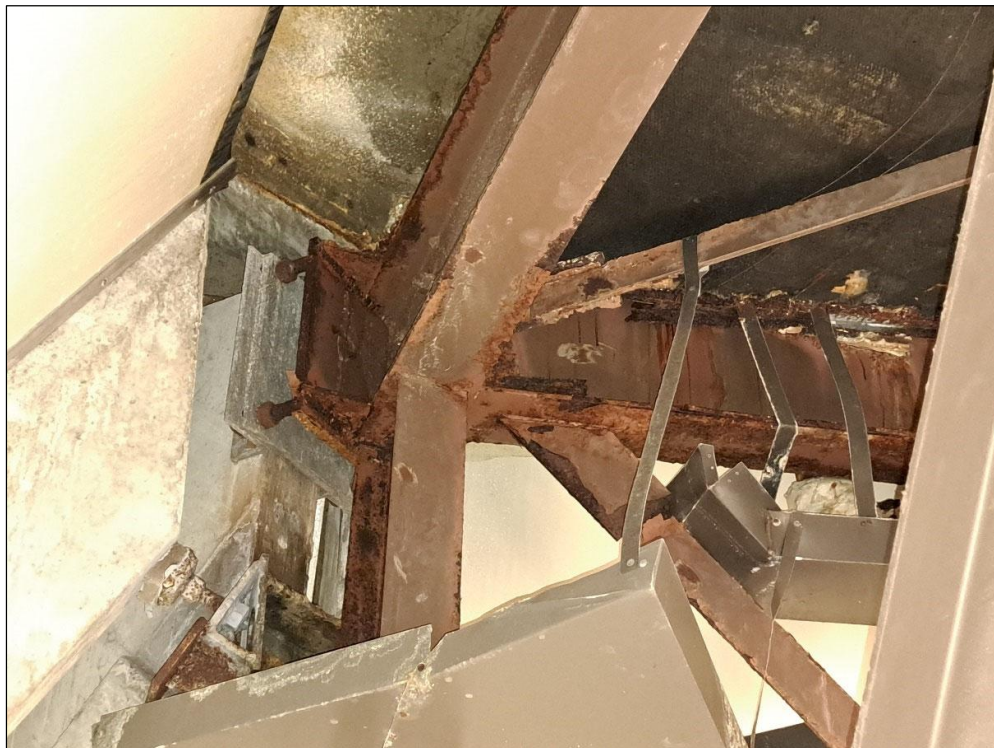
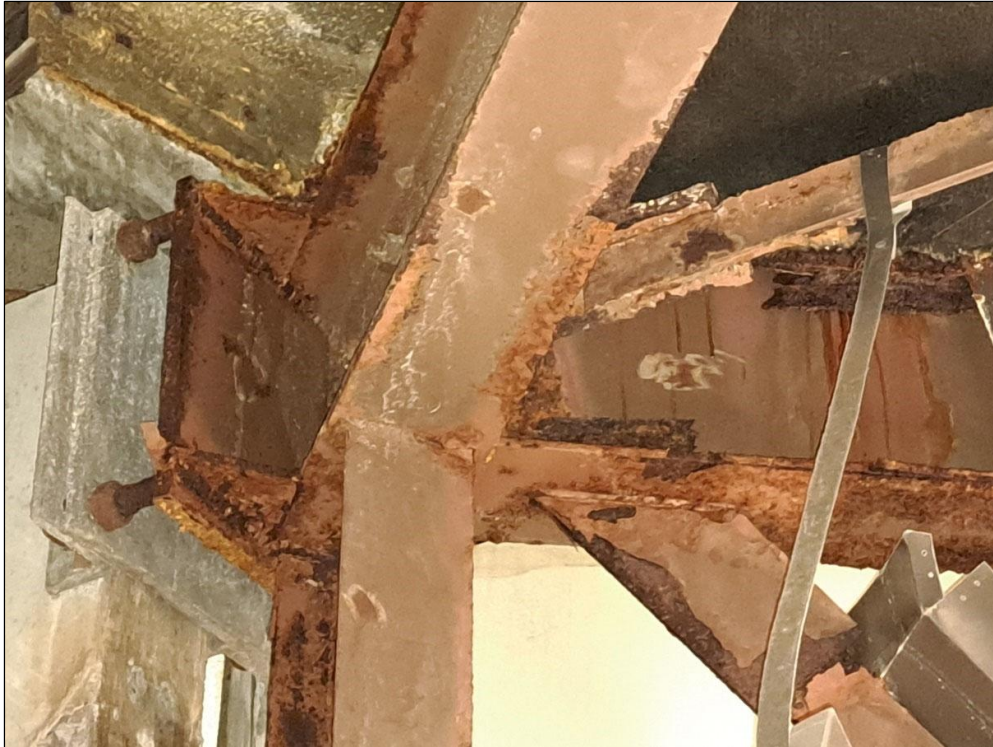
| LOCATION | BEAM TYPE | TEST LOCATION | THICKNESS<br>2018 (INCH) | THICKNESS<br>2022 (INCH) | BASELINE<br>THICKNESS<br>(INCH) | % LOSS* |
|---|---|---|---|---|---|---|
| NW Top<br>Connection | Main Vertical | S Flange | 0.295 | 0.285 | 0.30 | 5% |
| Figures 2 to 3 | | Web | 0.232 | 0.231 | 0.24 | 4% |

**Figure 2** NW corner top connection under roof.

**Figure 3** NW corner top connection under roof.

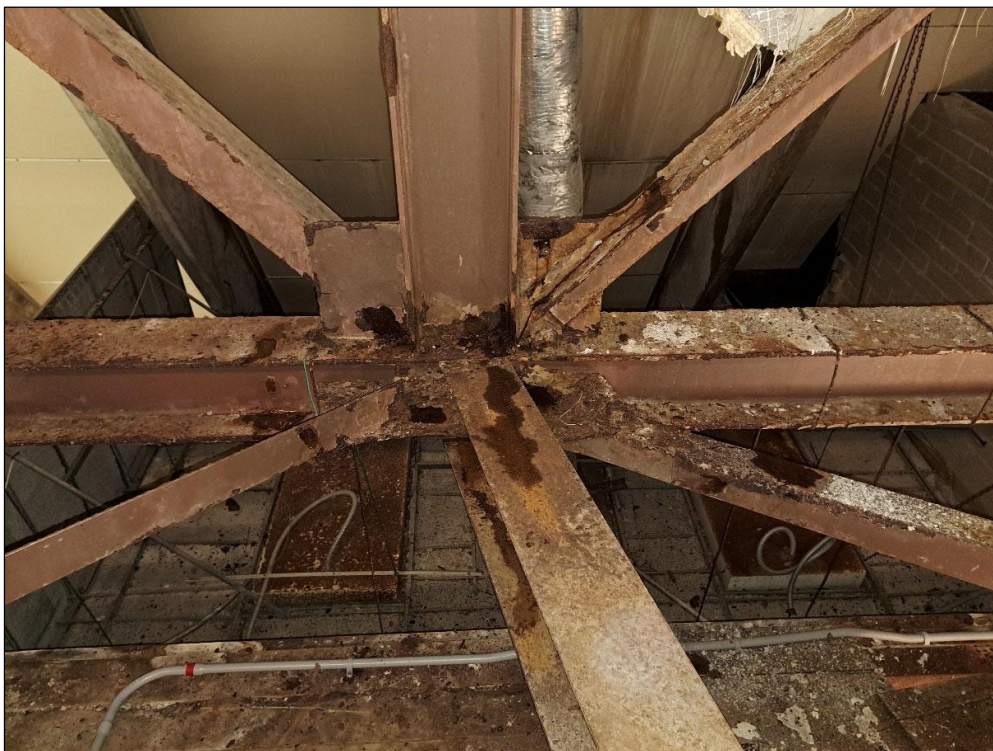
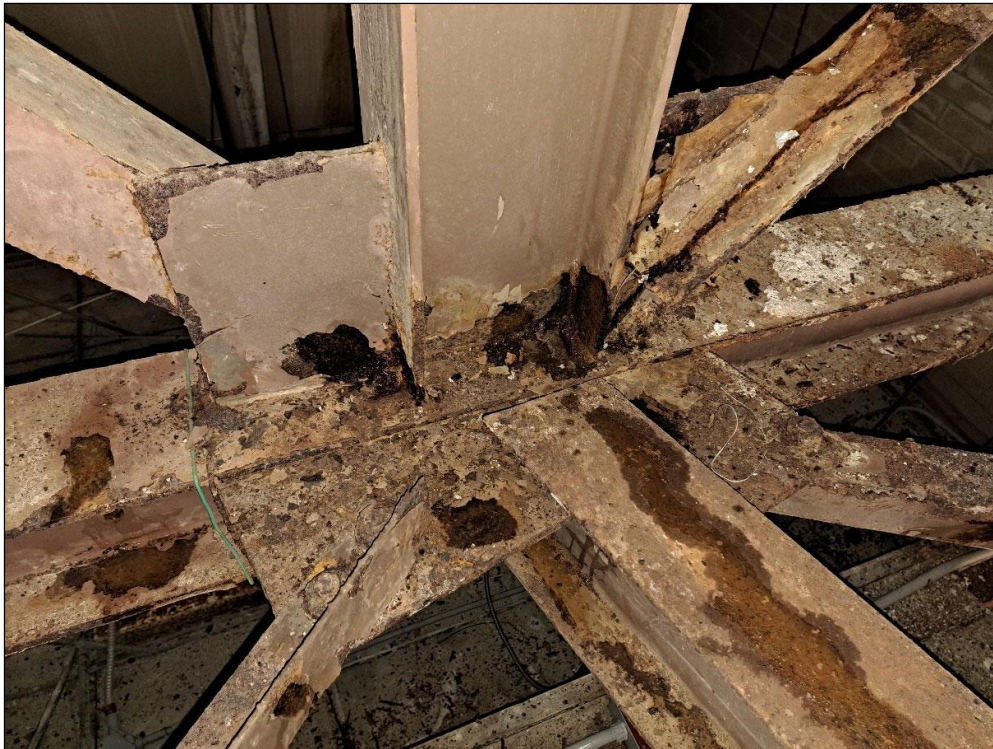
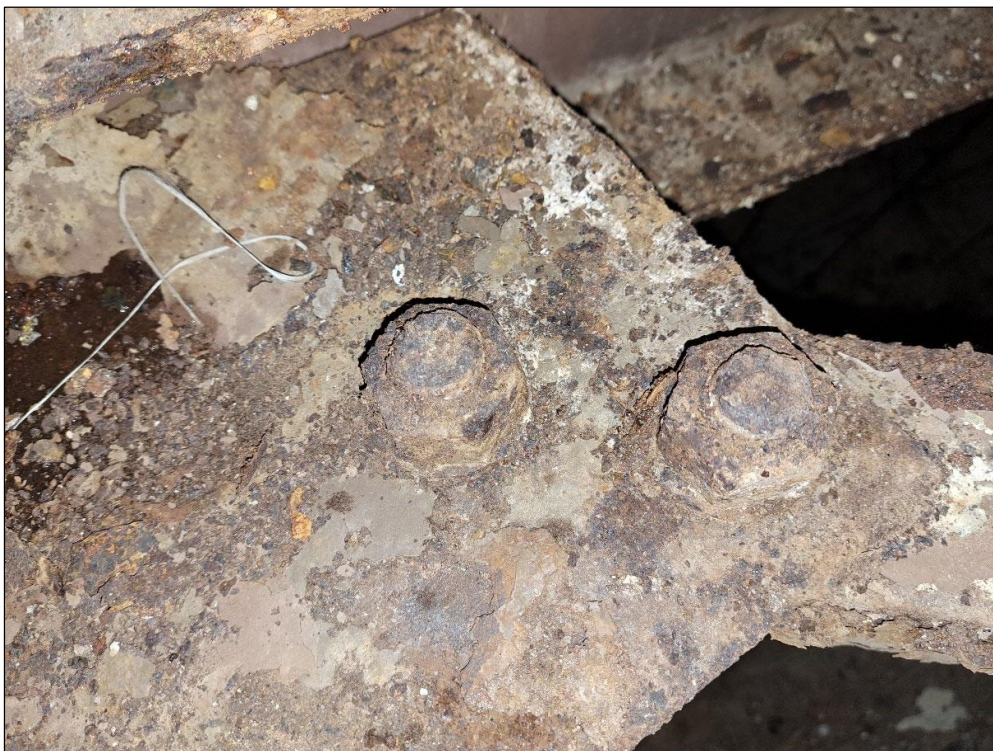
| LOCATION | BEAM TYPE | TEST LOCATION | THICKNESS<br>2018 (INCH) | THICKNESS<br>2022 (INCH) | BASELINE<br>THICKNESS<br>(INCH) | % LOSS* |
|---|---|---|---|---|---|---|
| Bottom<br>Connection | Main Horiz. Bottom<br>North | Top Flange | 0.385 | 0.361 | 0.39 | 7% |
| Figures 4 to 8 | | Web | 0.246 | 0.239 | 0.27 | 12% |

**Figure 4** NW corner bottom connection.

**Figure 5** NW corner bottom connection.

**Figure 6** NW corner bottom connection.

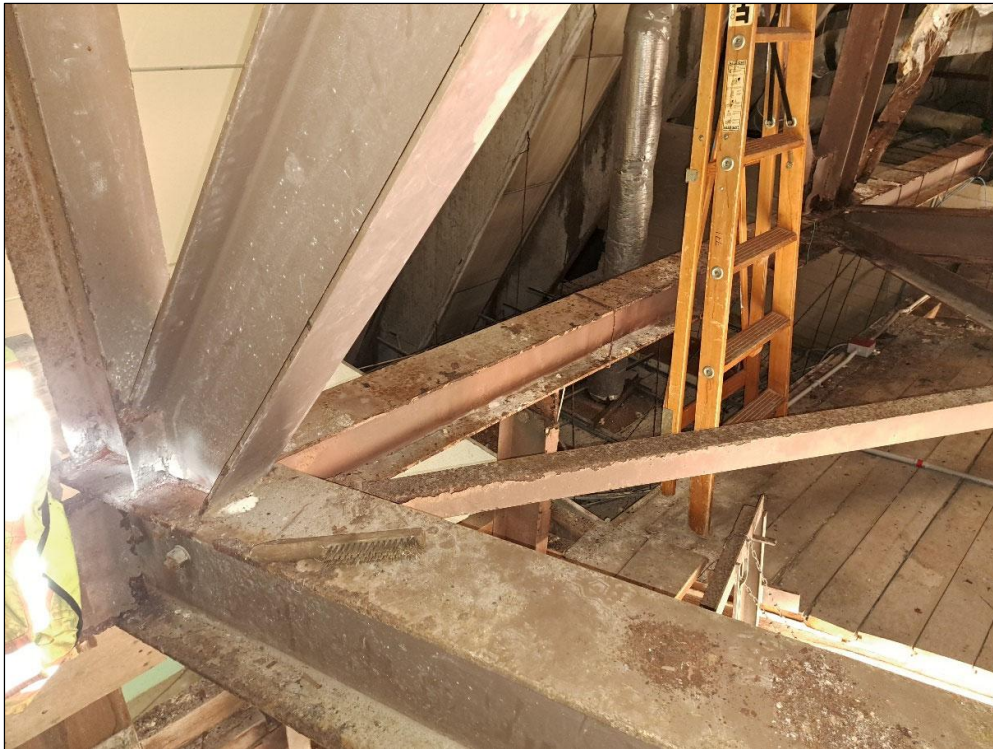
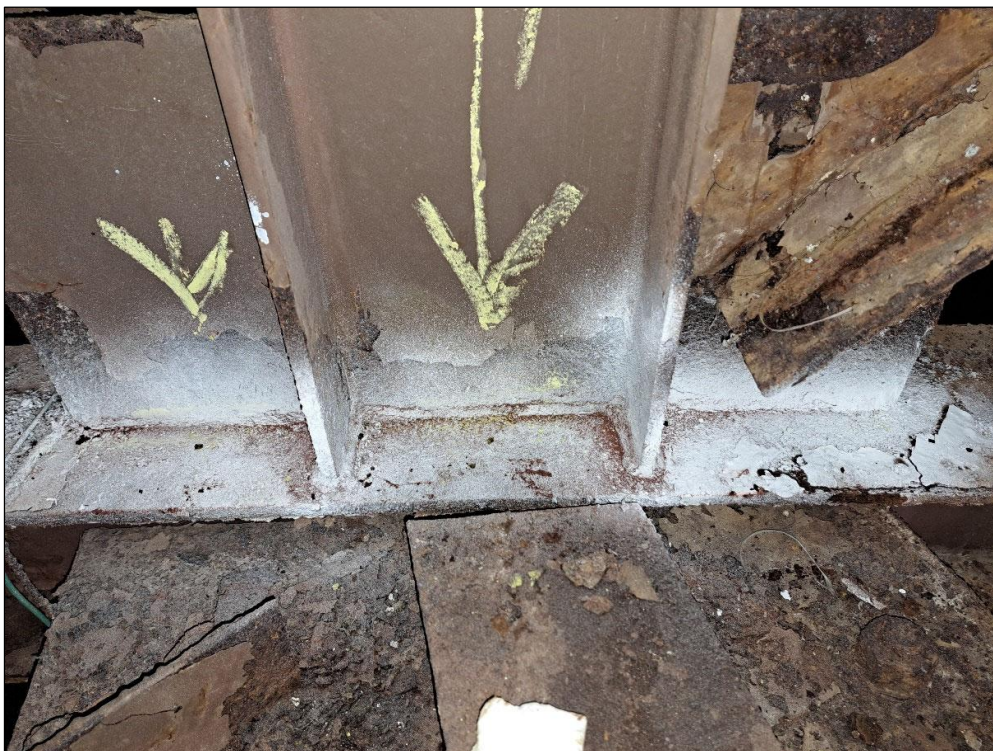
**Figure 7** NW corner bottom connection. MT results.

**Figure 8** NW corner bottom connection. MT results.

A dry visible magnetic particle evaluation with contrast paint of corroded two sample weld locations did not find any cracking indications.

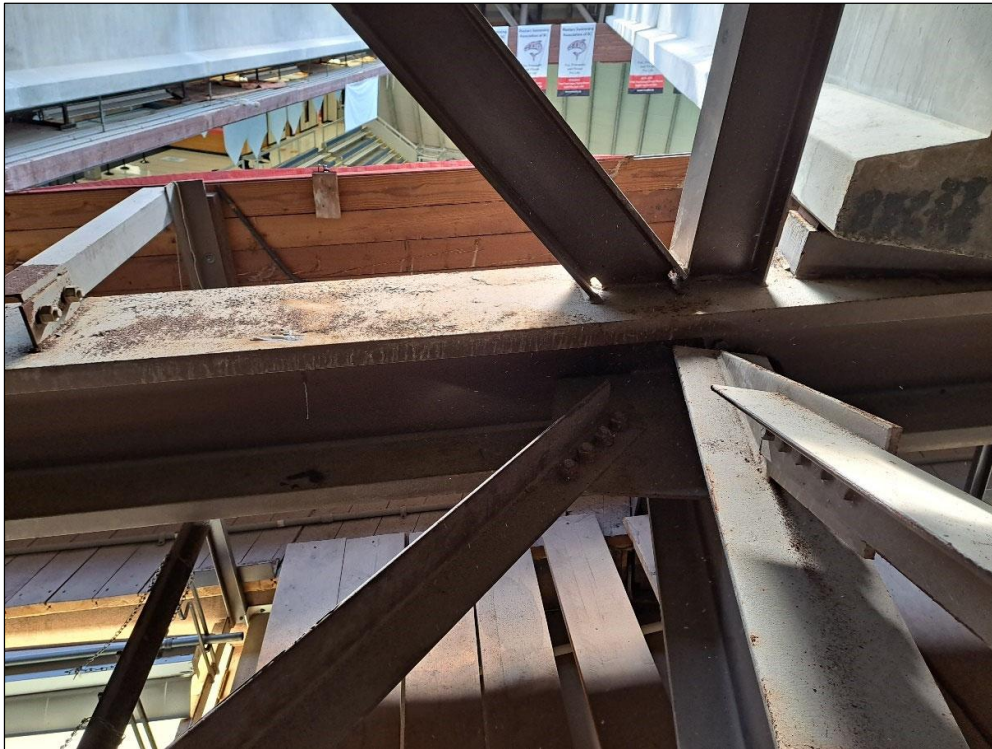
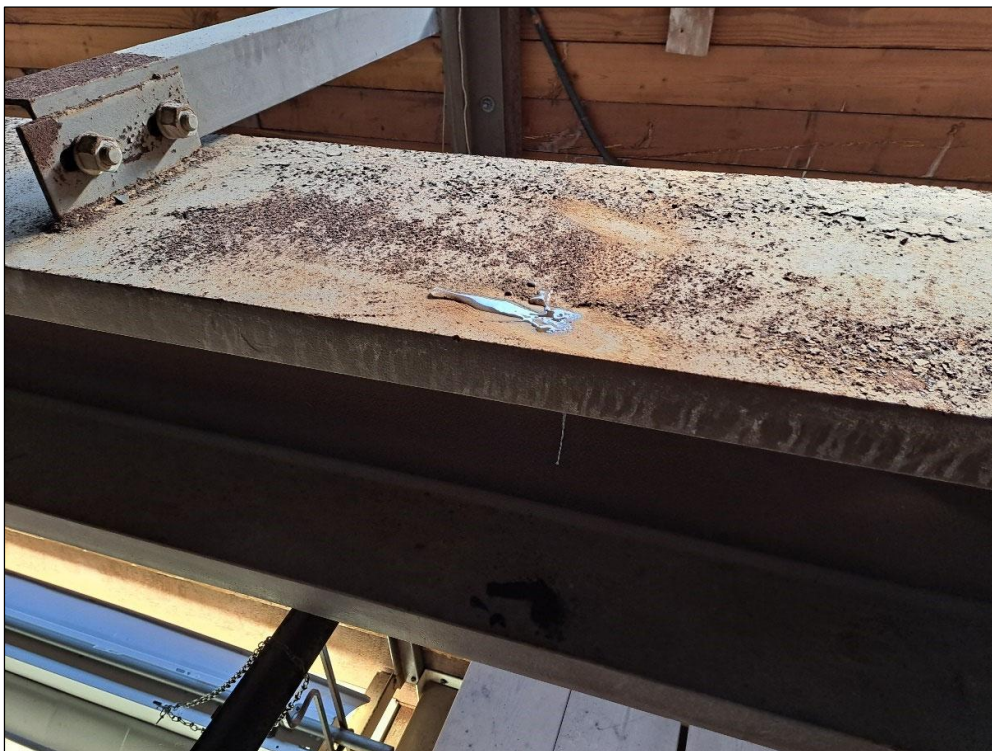
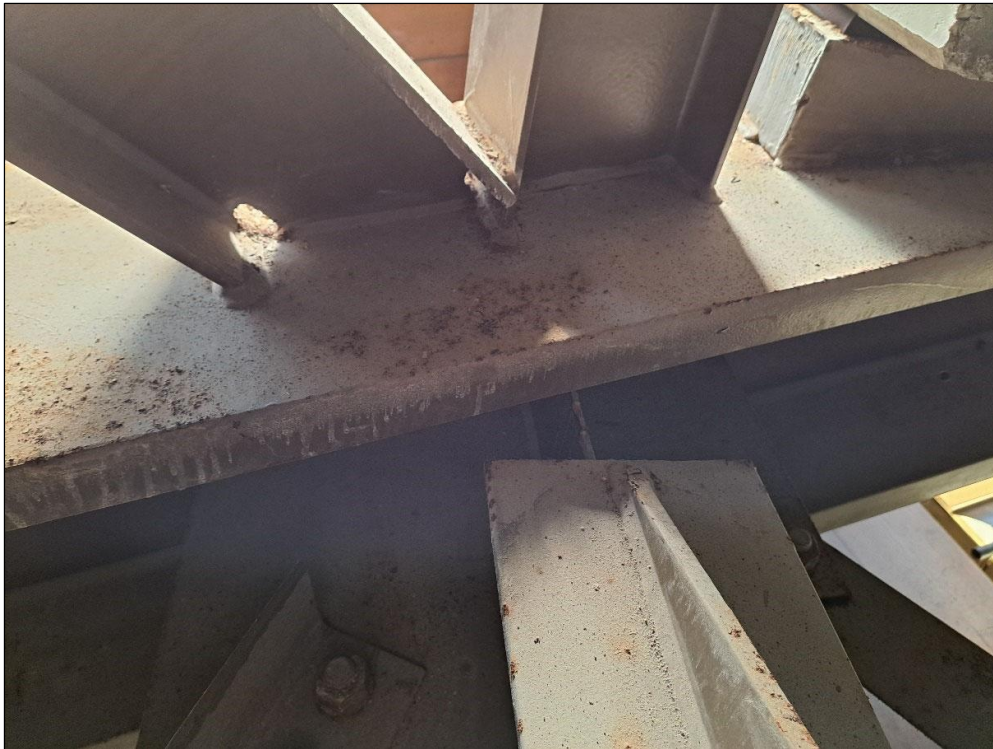
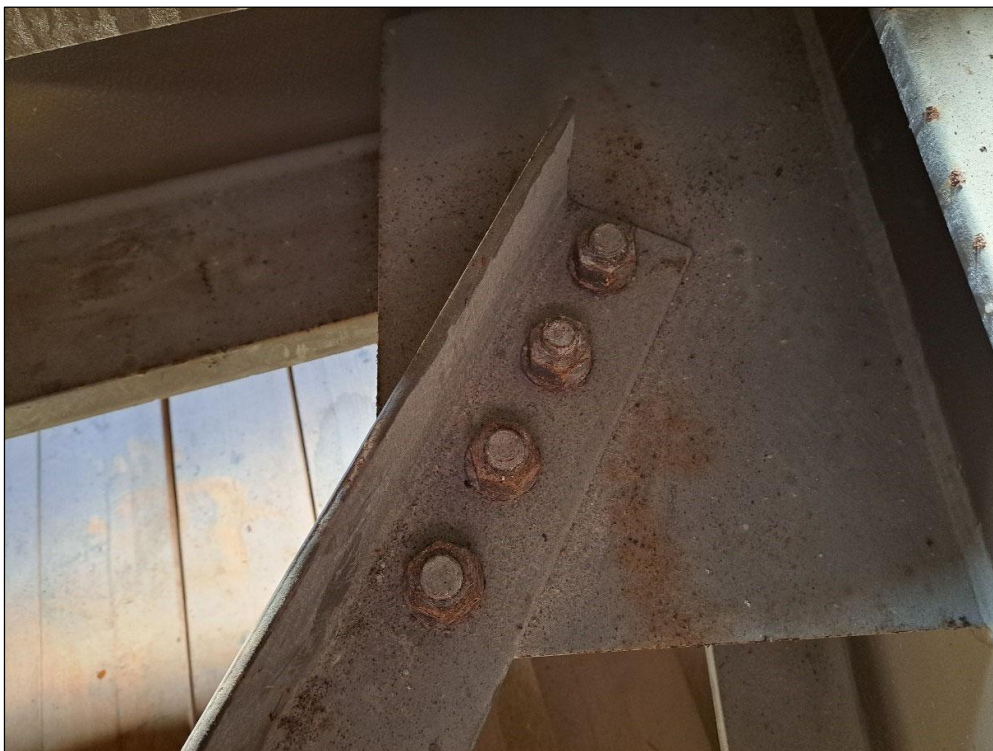
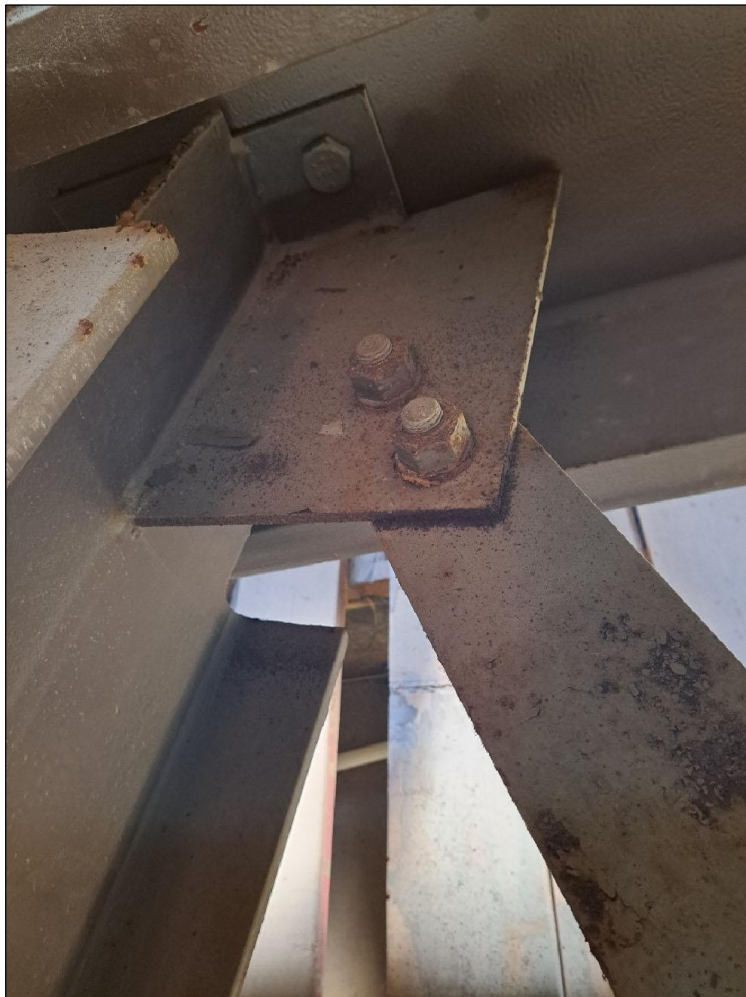
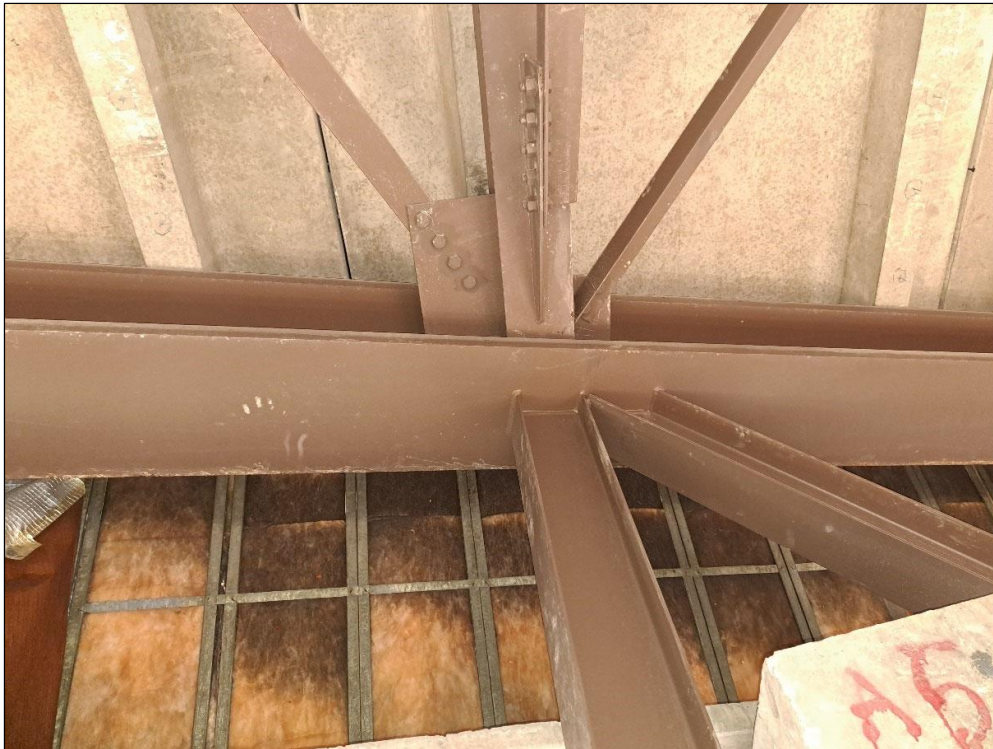
| LOCATION | BEAM TYPE | TEST LOCATION | THICKNESS<br>2018 (INCH) | THICKNESS<br>2022 (INCH) | BASELINE<br>THICKNESS<br>(INCH) | % LOSS* |
|---|---|---|---|---|---|---|
| Area No. 1 | Main Horiz. Bottom | Top Flange | 2.294 | 2.122 | 2.30 | 8% |
| West Side | | Web | 1.443 | 1.316 | 1.50 | 12% |
| Figures 9 to<br>14 | | Bottom Flange | 2.332 | 2.147 | 2.30 | 7% |

**Figure 9** Centre of West side structure, "No 1 Picture".

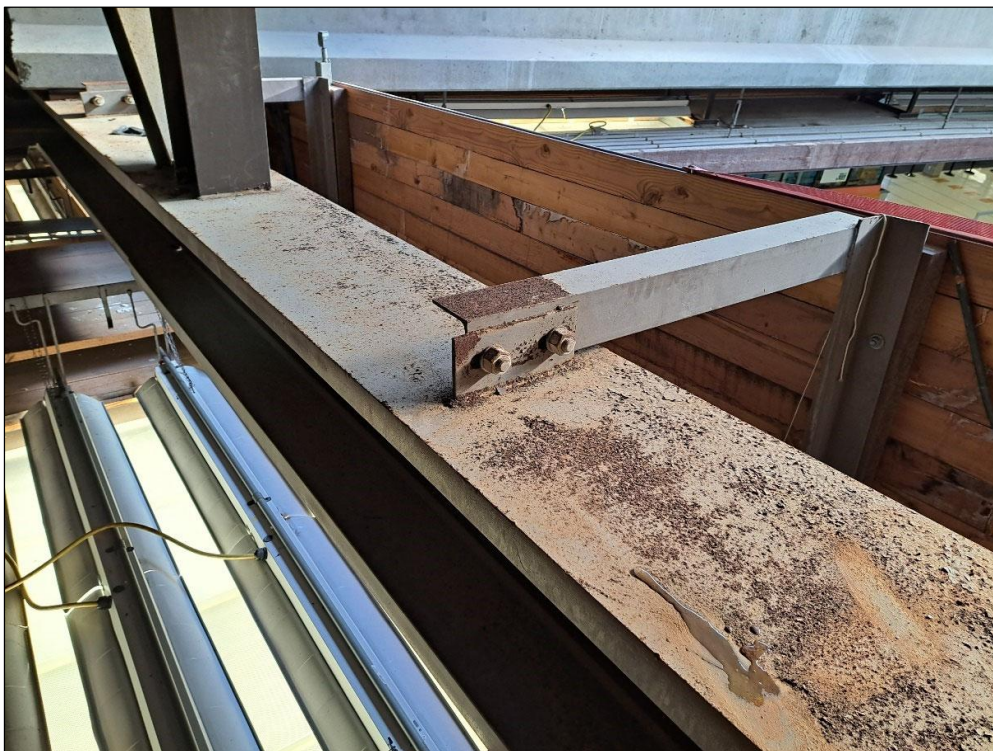
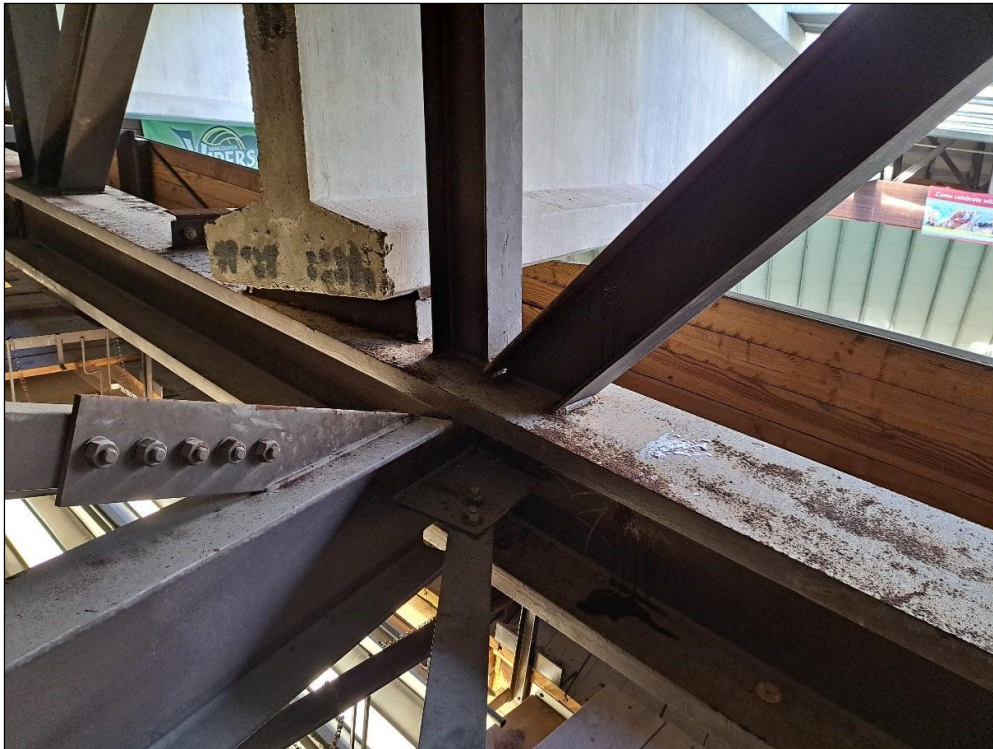
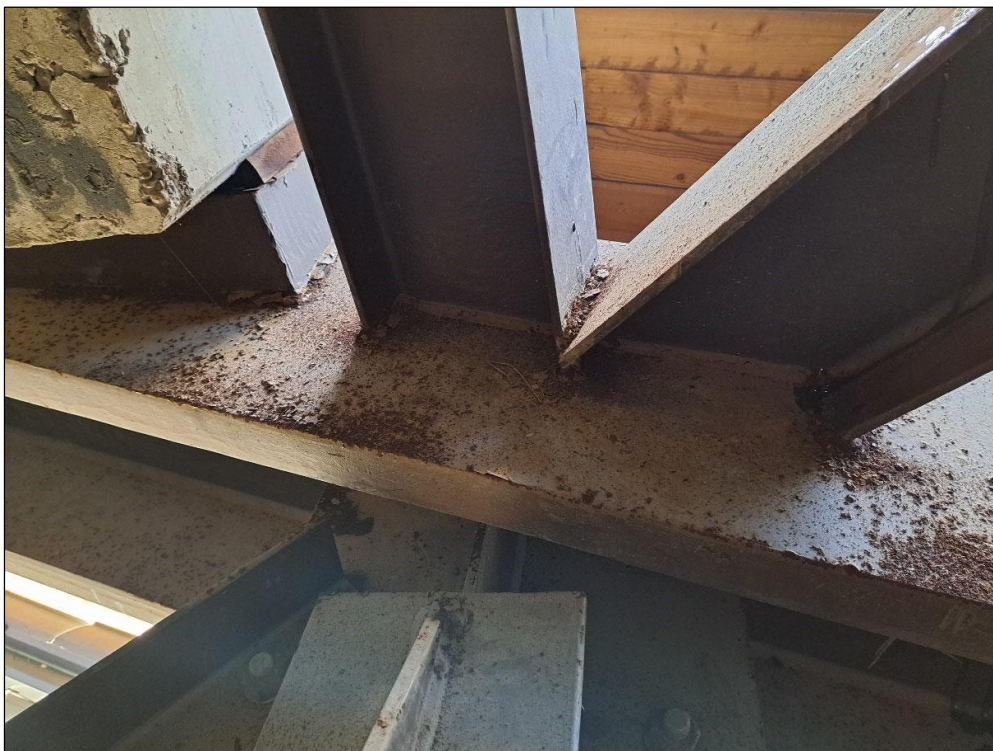
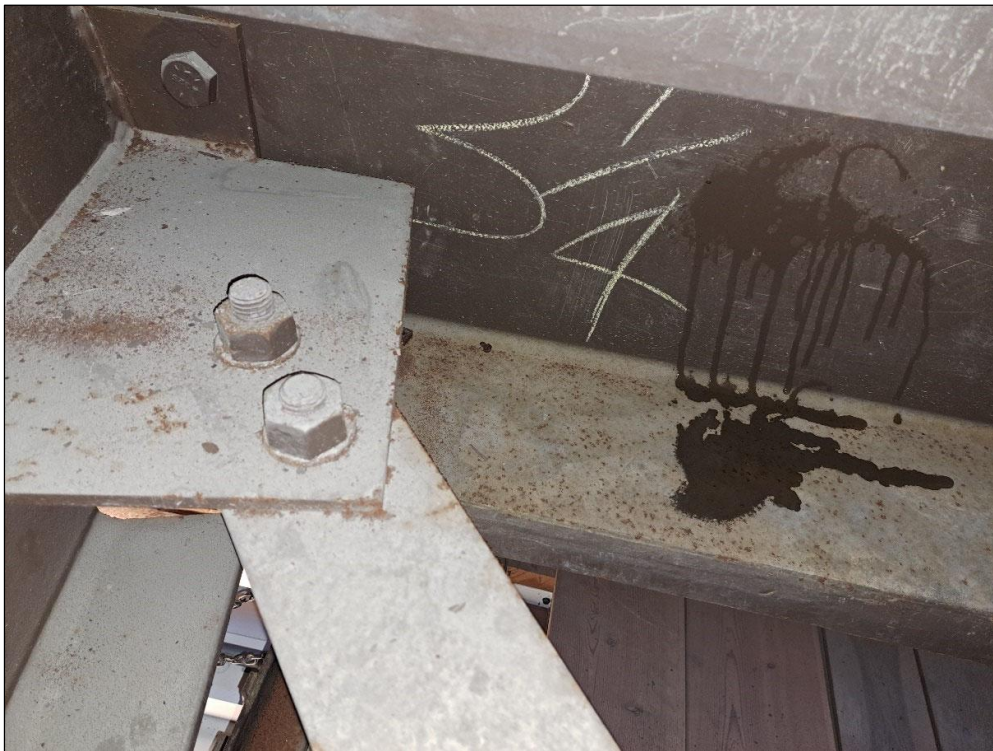
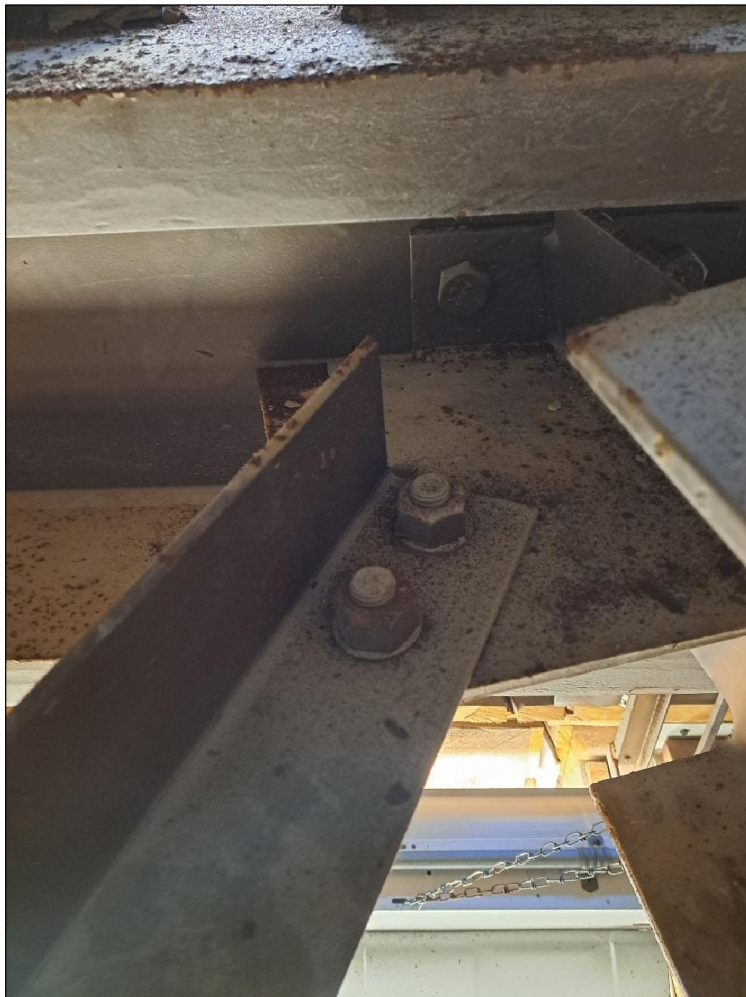
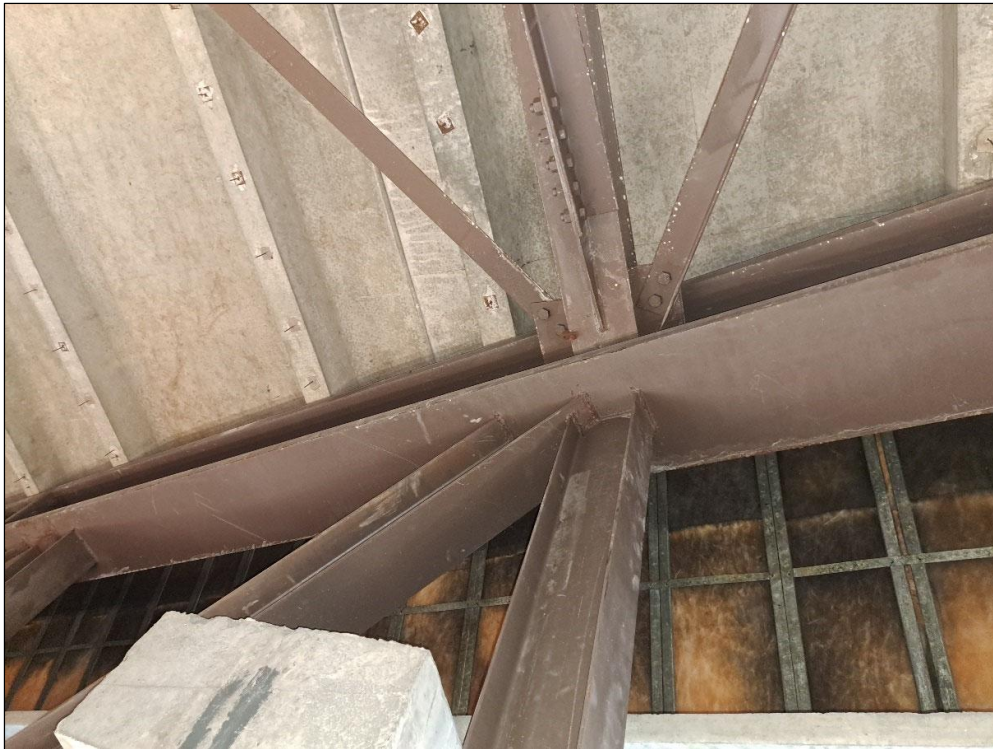
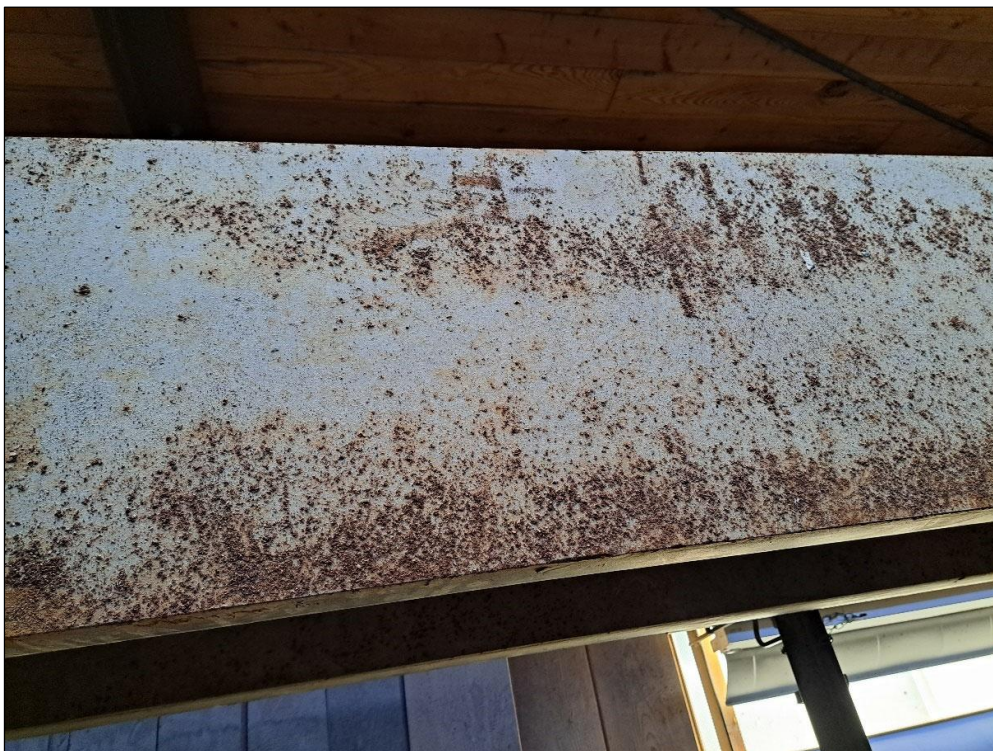
| LOCATION | BEAM TYPE | TEST LOCATION | THICKNESS<br>2018 (INCH) | THICKNESS<br>2022 (INCH) | BASELINE<br>THICKNESS<br>(INCH) | % LOSS* |
|---|---|---|---|---|---|---|
| Area No. 2 | Main Horiz. Bottom | Top Flange | 1.980 | 2.156 | 2.00 | -8% |
| East Side | | Web | 1.225 | 1.214 | 1.20 | -1% |
| Figures 15 to 21 | | Bottom Flange | 1.995 | 1.916 | 2.00 | 4% |

**Figure 15** Centre of East side structure, "No 2 Picture".
