## Vancouver Aquatic Centre Rehabilitation – Memorandum

**Attention:** Emma Artis, City of Vancouver  
**CC:** Tina Mathur, City of Vancouver  
**From:** John Sherstobitoff, Ausenco  
Reza Mortazavi, Ausenco  
Oon-Soo Ooi, Ausenco  
**Subject:** Options for Rehabilitation and Retrofit  
**Date:** February 17, 2023  
**Document Ref:** 107293-01-MEM-001, Rev.0

**Re: Vancouver Aquatic Centre Structural Steel Corrosion Assessment**

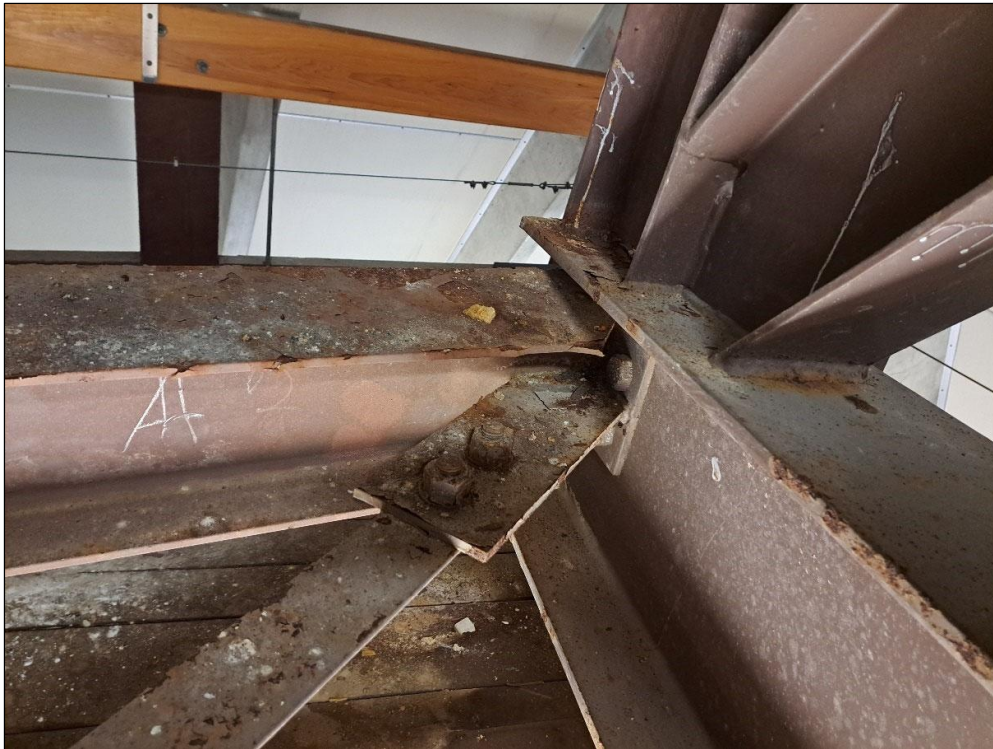
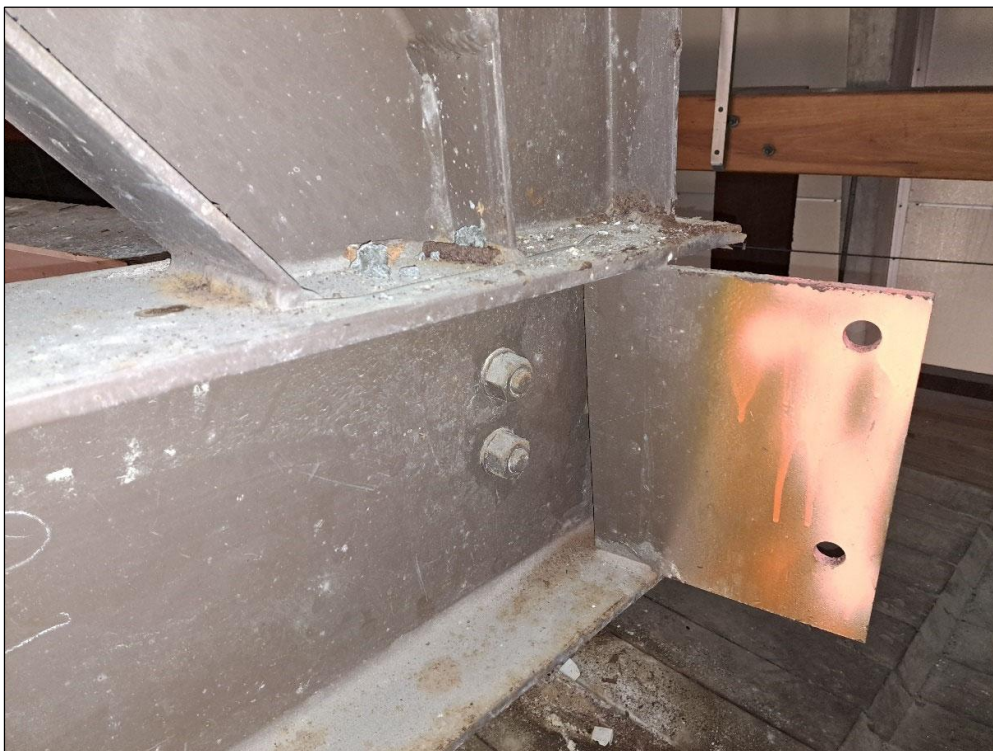
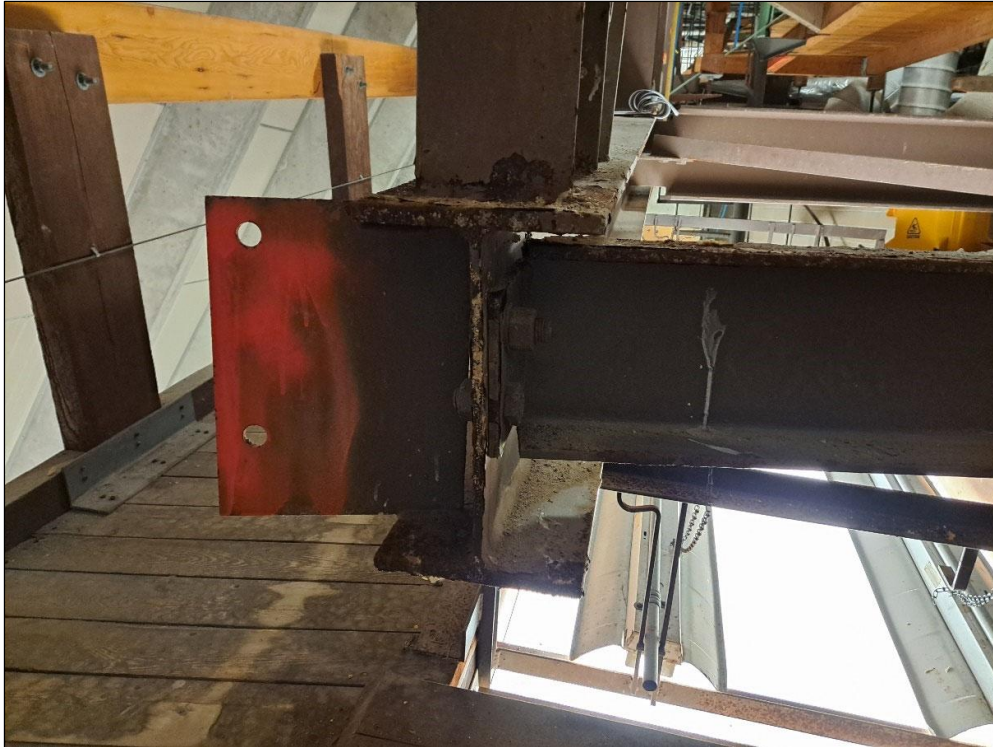
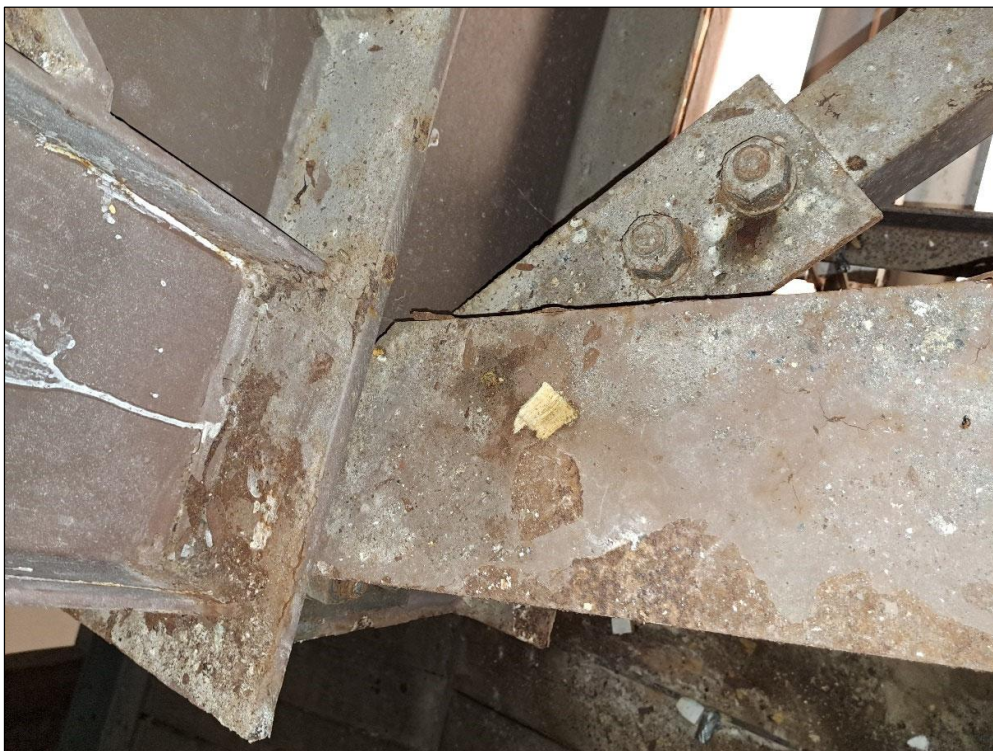
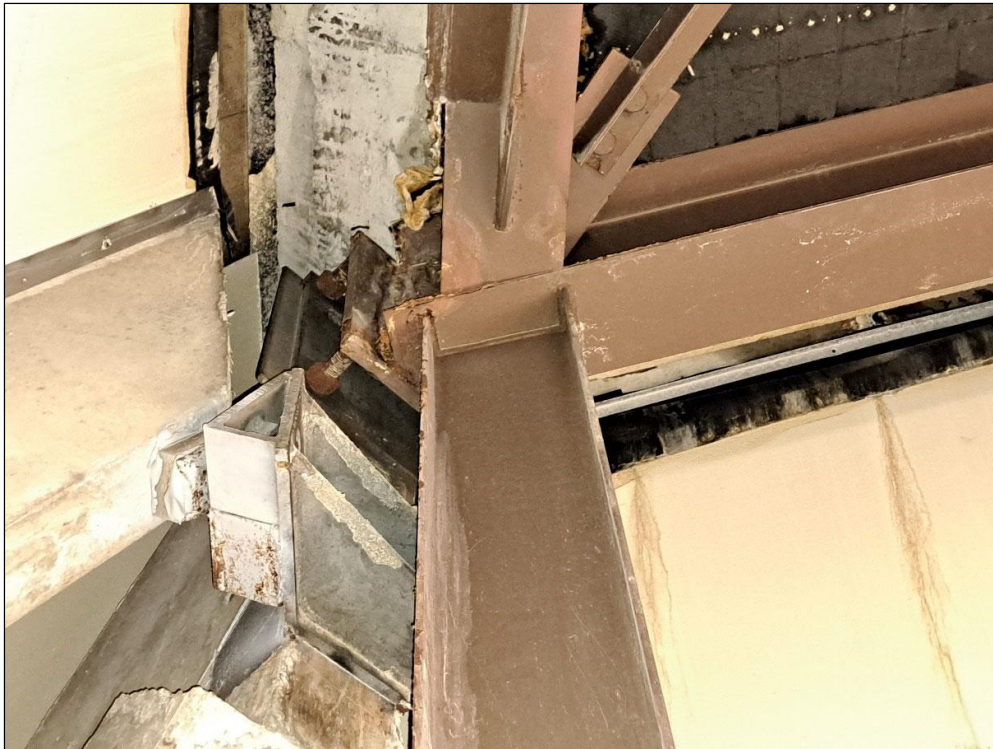
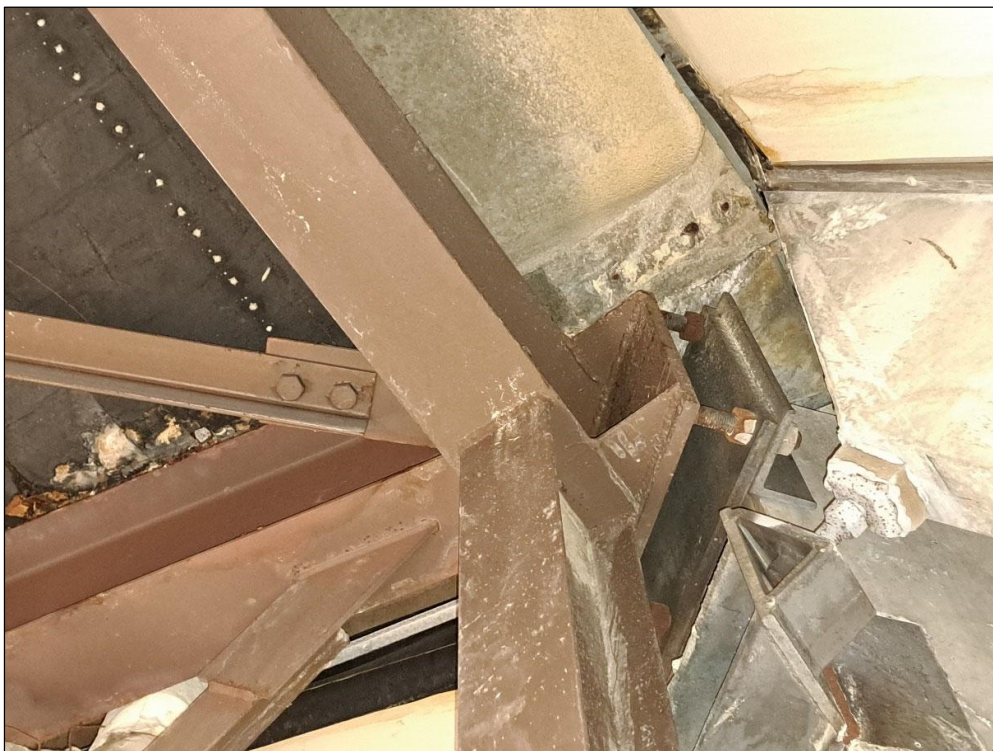
| LOCATION | BEAM TYPE | TEST LOCATION | THICKNESS<br>2018 (INCH) | THICKNESS<br>2022 (INCH) | BASELINE<br>THICKNESS<br>(INCH) | % LOSS* |
|---|---|---|---|---|---|---|
| NE Area No. 3 | Main Horiz. Bottom North | Top Flange | 0.393 | 0.360 | 0.39 | 8% |
| Figures 22 to 27 | | Web | 0.260 | 0.244 | 0.27 | 10% |
| | Main Horiz. Bottom East | Top Flange | 0.583 | 0.540 | 0.60 | 10% |
| | | Bottom Flange | 0.593 | 0.534 | 0.60 | 11% |

**Figure 22** NE corner bottom connection.
