## Vancouver Aquatic Centre Rehabilitation – Memorandum

**Attention:** Emma Artis, City of Vancouver  
**CC:** Tina Mathur, City of Vancouver  
**From:** John Sherstobitoff, Ausenco  
Reza Mortazavi, Ausenco  
Oon-Soo Ooi, Ausenco  
**Subject:** Options for Rehabilitation and Retrofit  
**Date:** February 17, 2023  
**Document Ref:** 107293-01-MEM-001, Rev.0

**Re: Vancouver Aquatic Centre Structural Steel Corrosion Assessment**

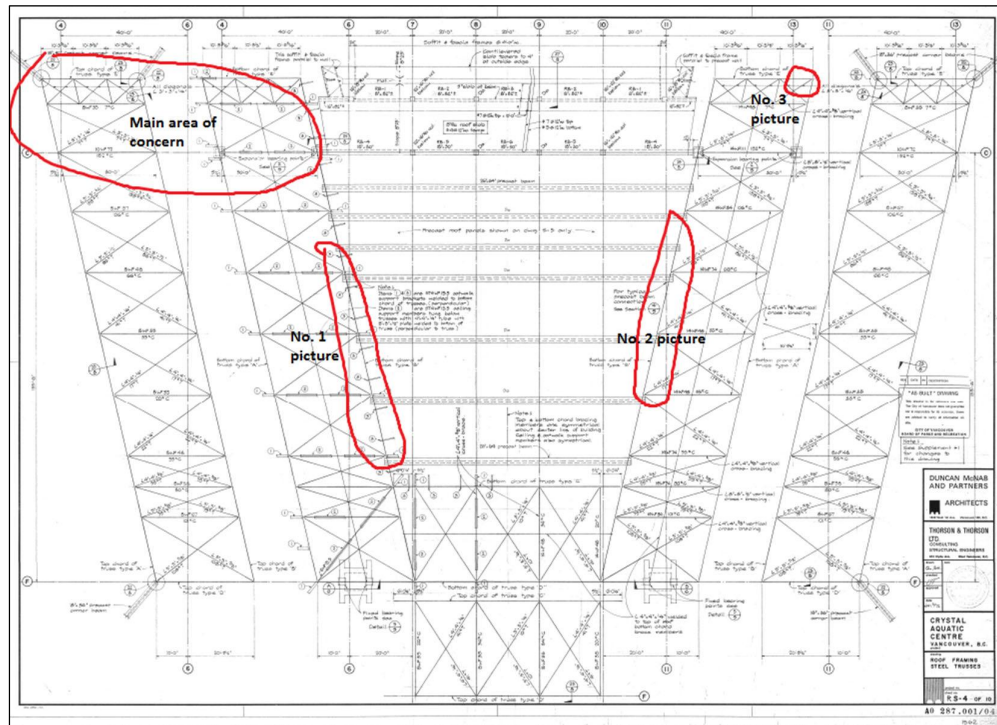
**Figure 1** Schematic of four test areas in VAC attic – roof framing steel trusses. North is approximately at the top (Beach Avenue).
